Analysis of Geological Risk Affecting the City of Toquepala, Southern Peru

Recuay – Ancash

Authors: Manrique Contreras Sergio Luis, Bravo Coronado Fidel Henry

Course: Geología Aplicada a las Construcciones

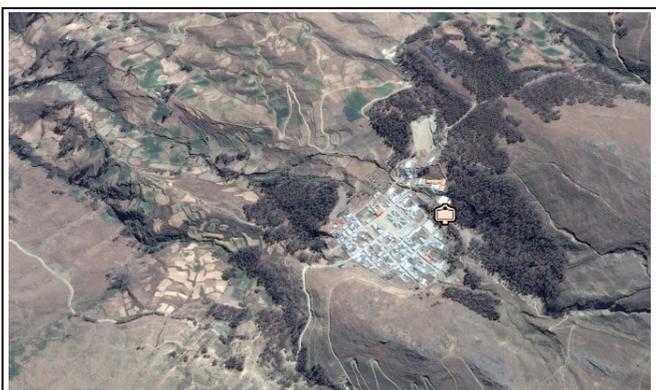
Fig 1 Tapacocha (Google Earth)

The town of Tapacocha District (Fig 1) is built on a sliding ground, consisting of materials unstable due to landslide erosion and sediment transport and rubble from the highlands

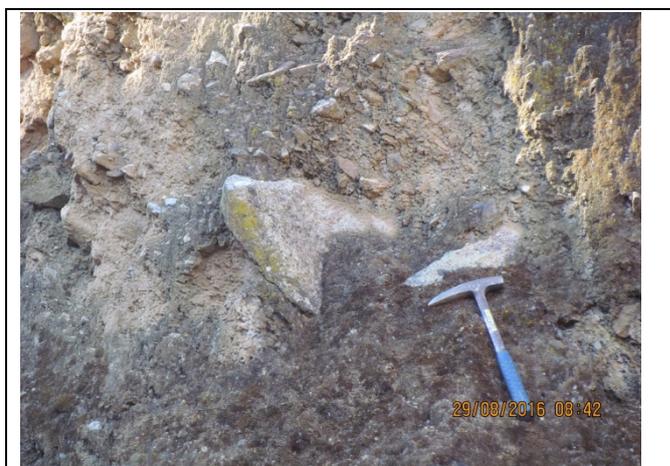
Fig 2. Tapacocha soil: clasts and debris of heterometric size and poorly classified

The town of the Tapacocha District is built on a slipped terrain, made up of unstable material caused by erosion landslides and transport of sediments and rubble from the highlands. The inhabitants mitigate with annual communal cleaning work to the areas of drainage and runoff located on the sides of the urban area. There were rainy seasons in 1983 that flooded part of the village, the fracture of the soil caused by the earthquake of 1970 (communication of the settlers). If the earthquake had occurred in the rainy season, it is very likely that large landslides were being lamented with considerable human and economic losses.

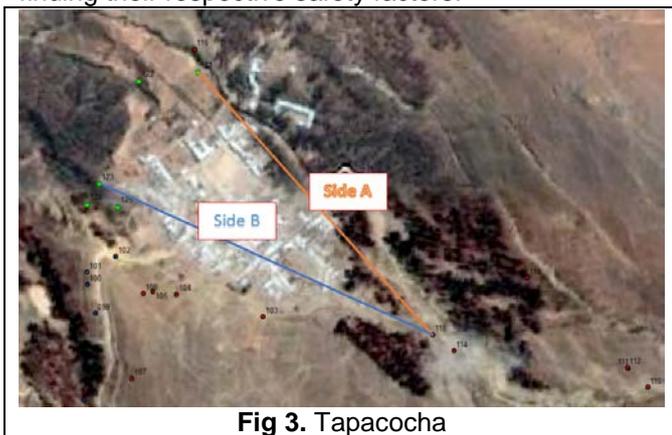
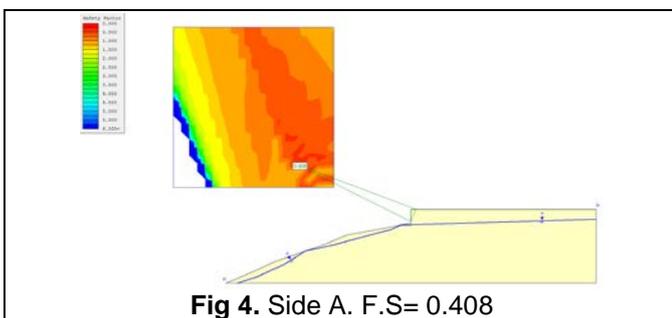
For the respective results, the soil of Tapacocha was analyzed according to the sections shown (Fig.3) finding their respective safety factors.

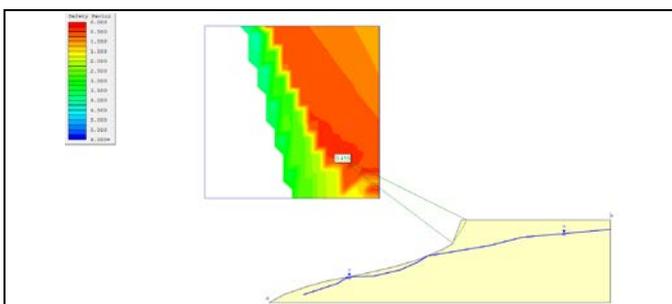
Fig 5. Side. F.S= 0.419
