Slope Stability Analysis of a sector of San Cristobal Hills

Subject: Geology applied to constructions

Universidad Nacional de Ingeniería

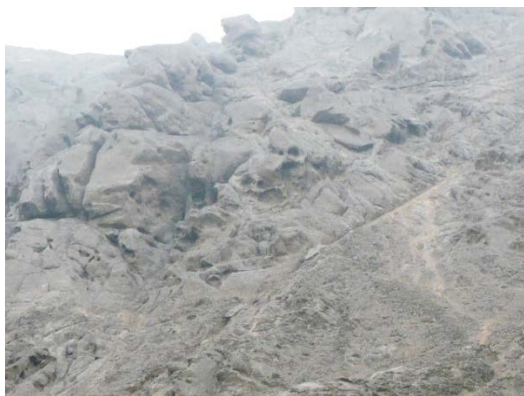
Figure 2. Blocks located on the slope.

In the project area, chemical weathering has slightly affected the rocky masses giving rise to residual soils and low potency colluvial soils. Small fallen blocks are observed due to the physical weathering, as well as blocks in the surface prone to fall before an earthquake, reason why the site is considered of average vulnerability, with mitigation activities could diminish the damages.

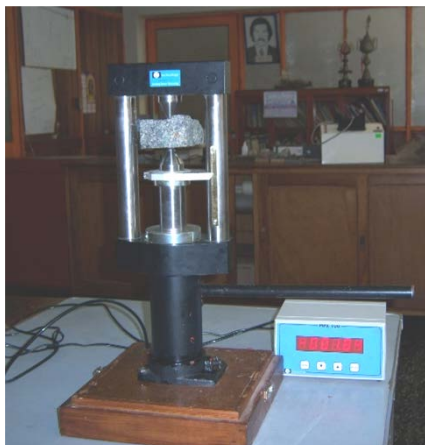
Figure 3. Digital punctual loading test kit model VJT6752.

Nine samples were collected in the eight measurement stations, with punctual loading tests being performed, obtaining their compressive strength. A digital punctual loading device model VJT6752 (Figure 4), which is a small, portable hydraulic press equipped with "load cones" between which vertices are placed the rock and/or mineral specimens, or cubic samples or blocks subjecting

them to compressive loads, until the sample rupture takes place.

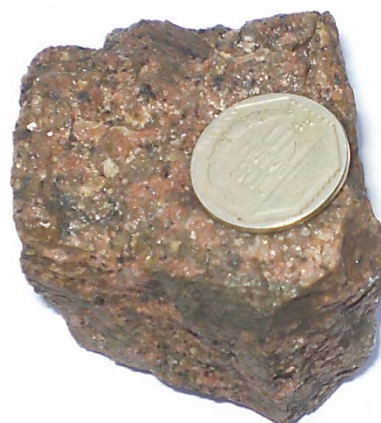
Figure 4. Medium grain biotitic granite (granular hipidiomorphic), incipient alteration (kaolin, sericite and chlorites).

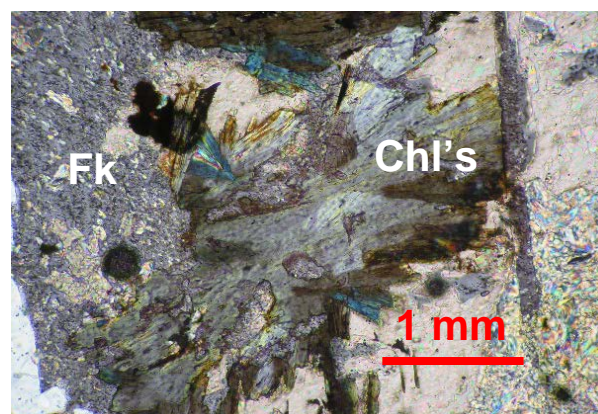
Figure 5. Biotitic granite with chlorites crystals by mafic minerals alteration, feldspars with moderate alteration transforming to kaolins and sericite. View on cross-bred niches.

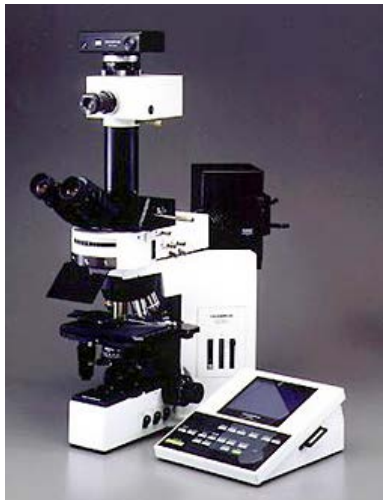
Figure 6. Olympus Bx Polarized Light Microscope

Rocks were identified with Olympus Bx polarized light microscope.

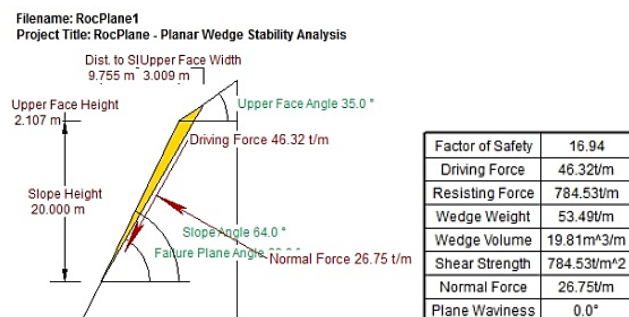
Figure 9. Slope 2D view with family forming the planar fault.

Considering only the slope angle and the family angle that causes the planar fault, the slope is not stable; with Rocplane software use the slope is stable, the difference is because in the first case only the orientation and the rock mass friction angle are considered, in the second case in addition to the orientations we consider the slope height and the parameters of cohesion and friction angle, obtained from the RMR.
