NATIONAL UNIVERSITY OF ENGINEERING

**DESIGN OF SLOPE STABILIZATION SYSTEM FOR A
TRAWLING HILL**

COURSE: GEOLOGY APPLIED TO CONSTRUCTIONS

2020

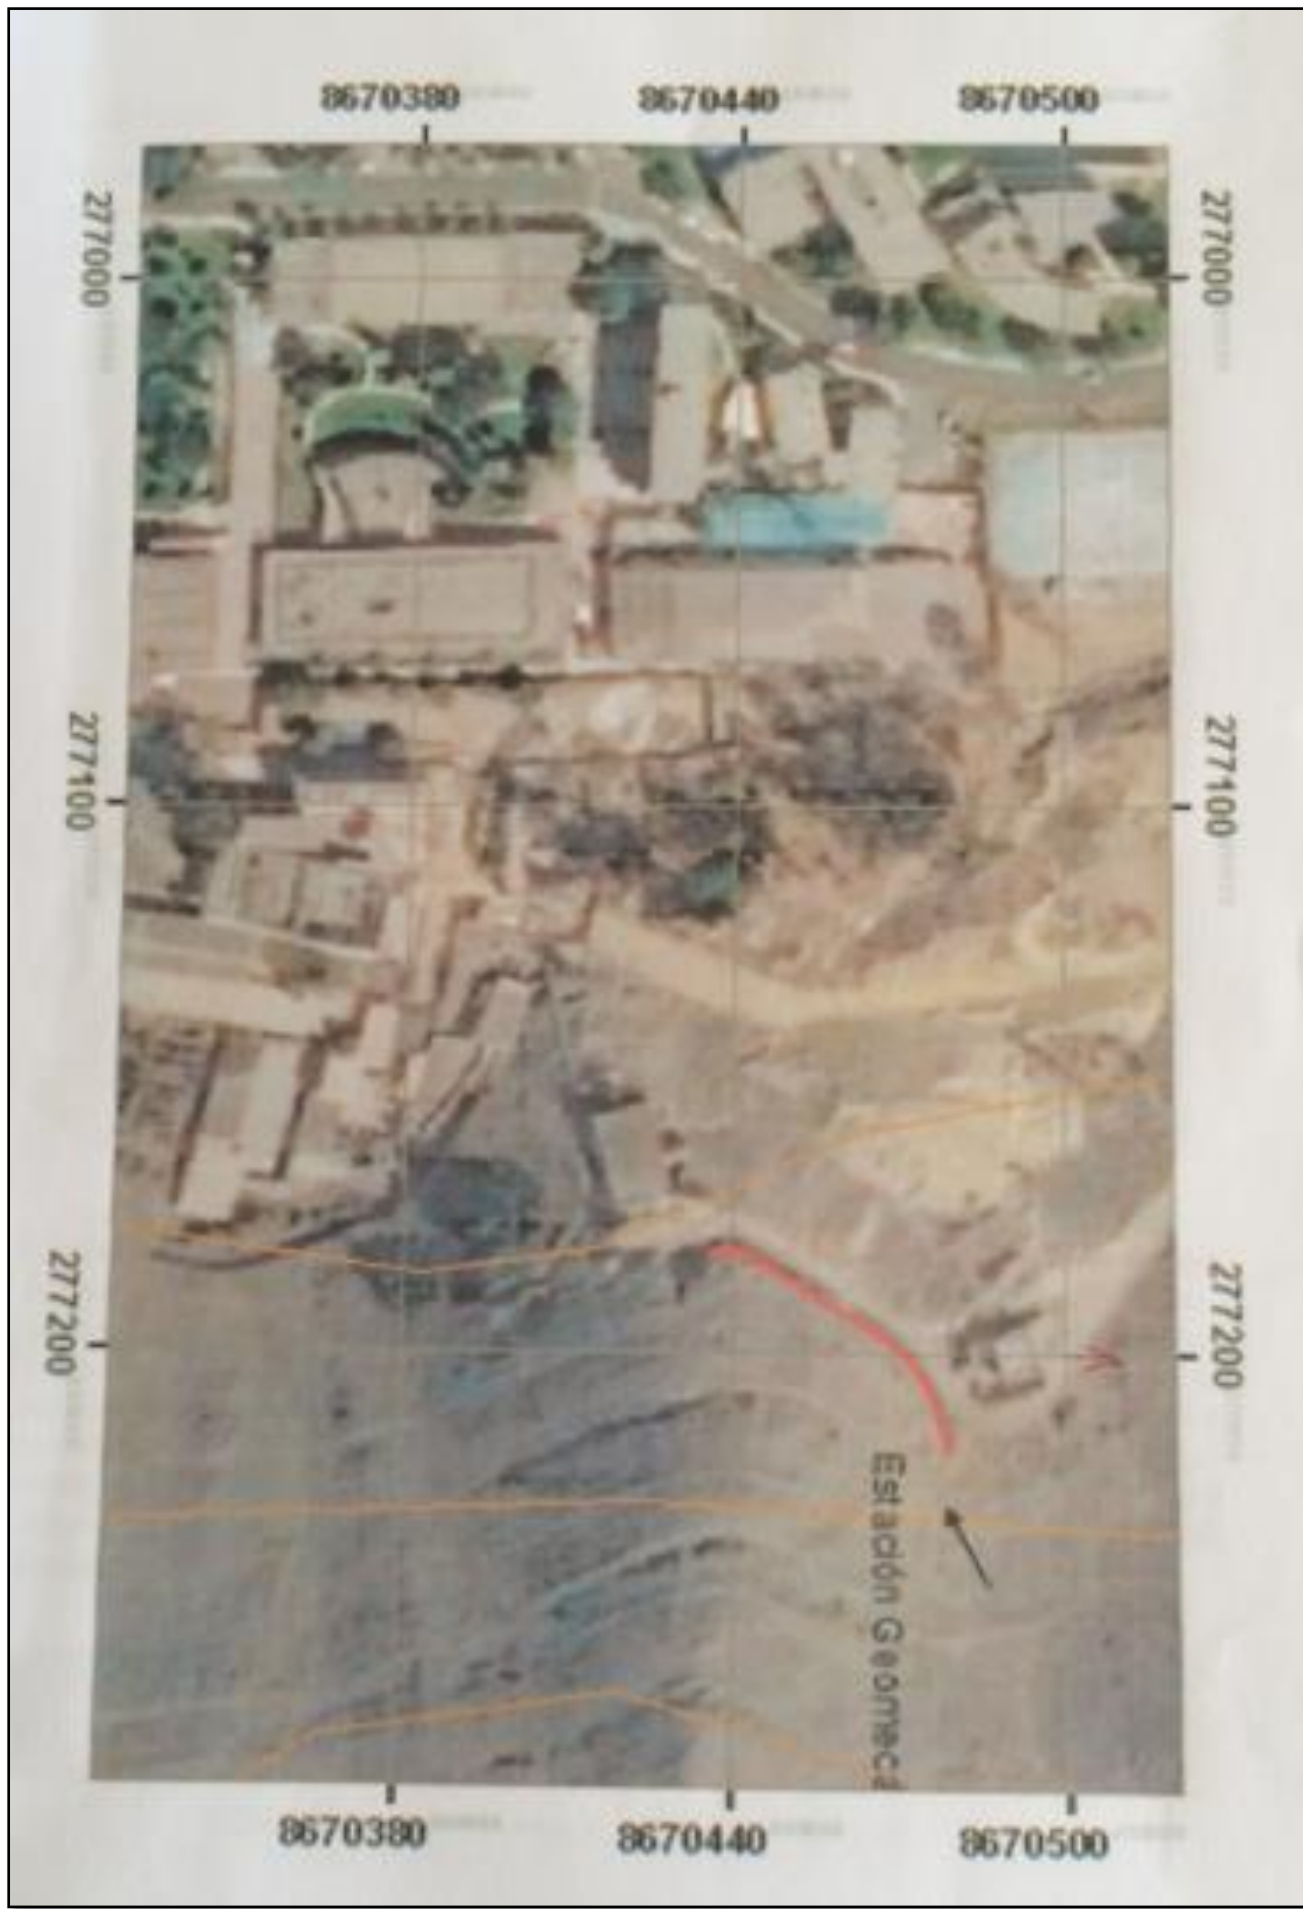
Figure 2: Field data collection procedure.

For the fulfillment of the proposed objectives, after some theoretical sessions on geomechanical stations and stability analysis of slopes; the field work consisted mainly of data collection (100 data) required in formats for the characterization of the rocky massif.

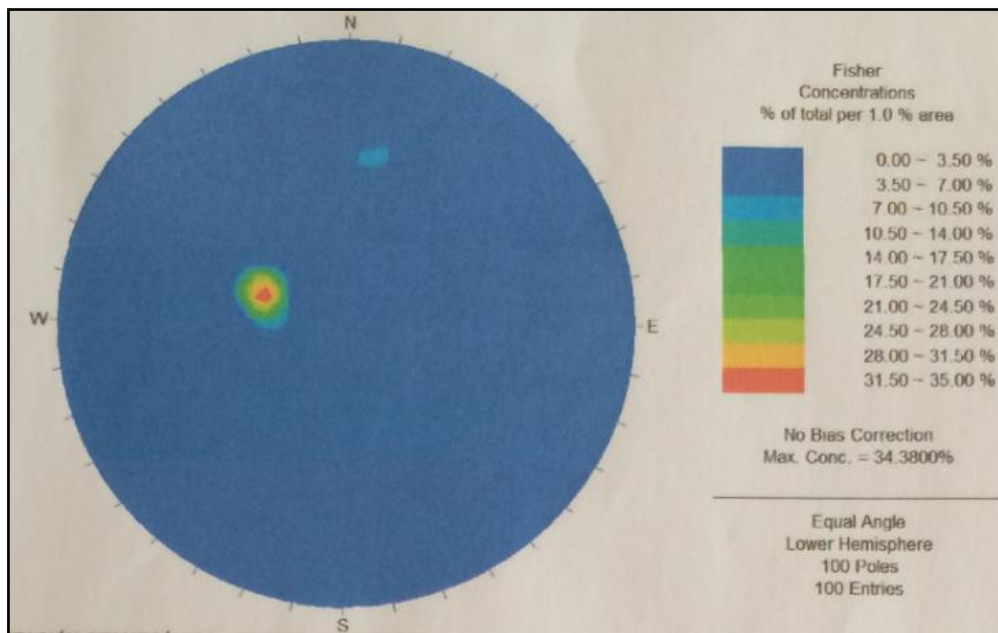
Figure 6: Representation of clouds of concentration of poles.

- Plotting points will show (in the window of contours or clouds) the zones with the highest concentration of poles of generated planes.
